2 PROBLEM BACKGROUND

3 INSPECTION OF STRUCTURAL STATE AND STATION WATERPROOFING

4 EXECUTION OF RECONSTRUCTION AND WATERPROOFING WORKS

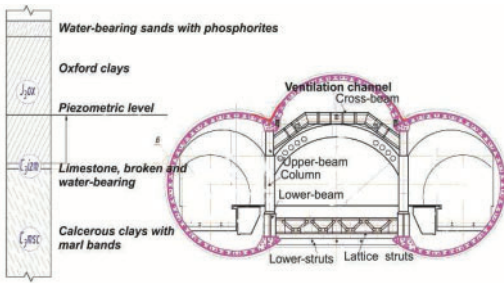
Figure 2. Geology in the area of Mayakovskaya station. Station Cross-section.

Another factor which defines the quality of waterproofing is the geological environment of an underground structure. Moscow is located in the centre of the so-called Russian platform which has a vast crystalline foundation covered by a layer of basic sediments, upper part of which is represented by man-made soils, loams, clay sands, and unstable water-saturated sands. Deeper these are followed by clays with bands of limestone. Station structures lay mainly in this layer. It shall be noted that the vault of the station is located in Oxford clays with bands of water-bearing sands and phosphorites, the presence of which had not been known and hence accounted for at the design stage (Fig. 2).

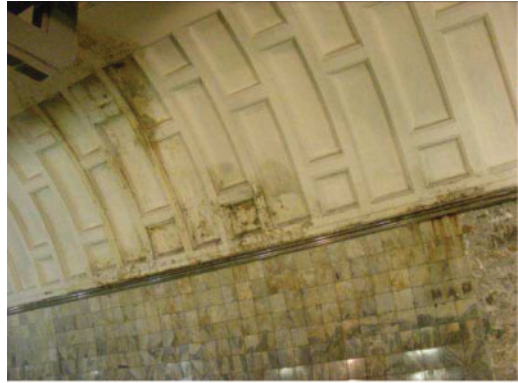
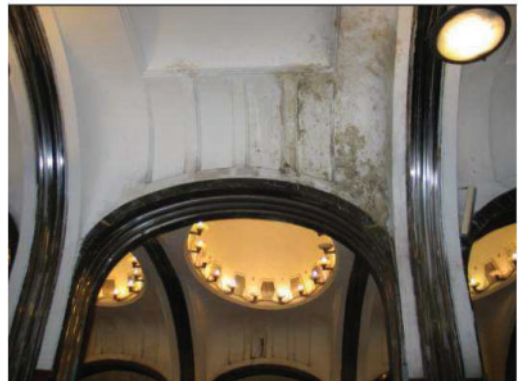
As years of operation resulted in multiple failures of lining watertightness, ground water came directly to steel framework structures and reinforced concrete. Original drainage system failed as well: metal ducts were fully corroded, drainage pipes were completely mudded.

Intensive corrosion of metal structures and concrete reinforcement caused deterioration of finishing

Figure 3. Regular multiple leakages caused deterioration of station finishing.

materials. There appeared water leaks and drips in passenger passage areas.

structural wetting and spoilt finishing and decorative elements (Fig. 3);

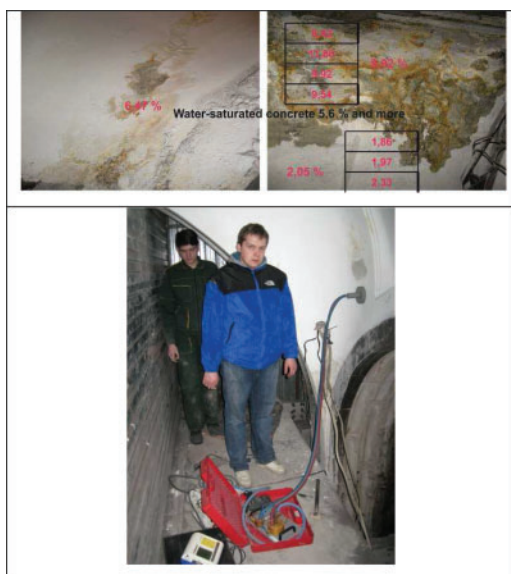
Figure 5. High permeability of concrete caused leakages and structural deterioration.

Concrete tests confirmed high degree of water penetration: W2, whereas current norms state W4 as the standard value (Kirilenko 2013). Concrete around the leaks was wetted to different extent (Fig. 5).

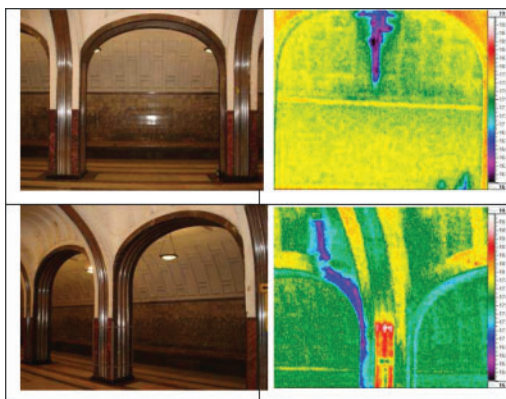
Infrared thermography was used to locate wetted areas which could not be defined visually, though clearly seen as “thermal spots” on structural surface (Fig. 6). Besides, it helped to create general map of heat distribution within the structures (Shilin et al. 2015).

Figure 6. Station structures in visible and infrared ranges.

- quite a number of areas were located where surface wetting could not be identified visually, though present inside the structures; those areas demanded urgent restoration of waterproofing;
- it was stated that water came mainly via the escalator tunnel which crossed water-bearing layers of soil.

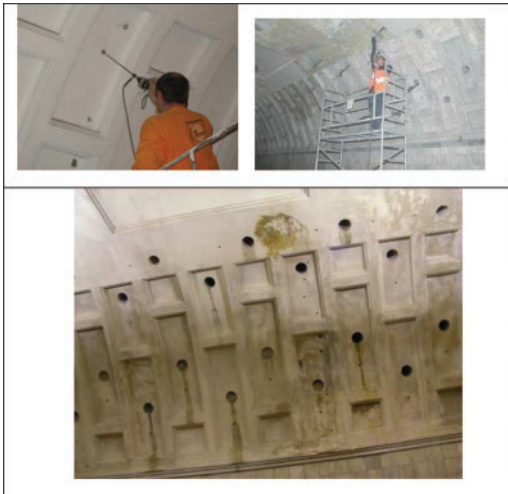
Figure 7. Locating and correcting positions of cementing ports.

structures, which we did with the help of endoscopes in the following way. First we drilled small holes (dia. 18 mm) in the places shown at the design drawings and inserted rigid endoscopes into them (Fig. 7). The images we got from inside the structures allowed to make corrections – if necessary – to drill afterwards holes of bigger diameter (80–100 mm).

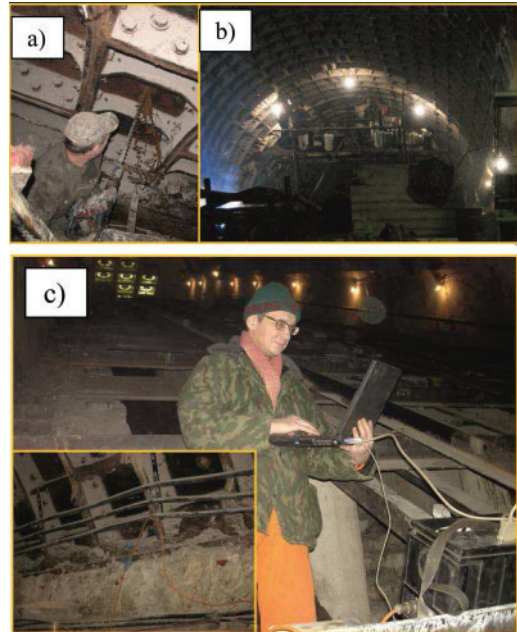
Figure 8. Drilling of a borehole through a cementing port in the segment (a), injections from the trolley-based rig (b), impact echo tests for quality control of injections behind the lining (c).

In the traction equipment chamber injections were carried out from the existing running bridges, in the escalator tunnel a special trolley-mounted rig was assembled for the purpose. Plugs from cementing ports were pulled out; through the ports boreholes were drilled to the depth of 500 mm crossing the layer of concrete plugging injected at the time of construction (Fig. 8a).

Quality of injections was controlled visually, by impact-echo tests (Fig. 8c), and also with the help of rigid/flexible endoscopes inserted into specially drilled boreholes. Besides, selective water tests were carried out, as well as continuous infrared thermography in the end.

Cavities located by thermography and test drilling as well as sections of water filtration behind the tunnel lining were first injected with rigid hydro active polyurethane with expansion ratio of $K = 10$, and then with rigid/flexible hydro active polyurethane with expansion ratio of $K = 3-4$. Such scheme allowed to begin with creating a waterproofing membrane and further to increase its reliability by filling the majority of minor irregularities, such as caverns, cracks

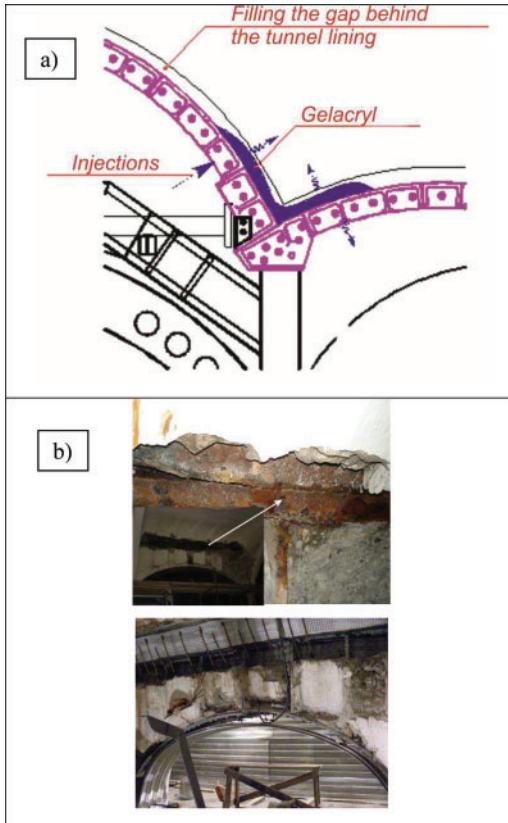
Figure 10. Scheme of polyacrylate gel injections (a), refurbishment of the failed drainage system (b).

At this stage a two-component polyacrylate gel was injected. This gel was capable to penetrate not only into the contact zone between the lining and surrounding soils, but also into fine cracks and pores in structures and soil (Fig. 10a). The job was carried out on a round-o'clock basis from the station vent channel.

After the injections into the contact area were finished, we started to install the drainage system, which included both the refurbished existing parts and new ducts and pipes. The new part was fabricated from modern corrosion-resistant FRP materials;

additionally PVC flashings were installed instead of old ones made of ruberoid (Fig. 10b).

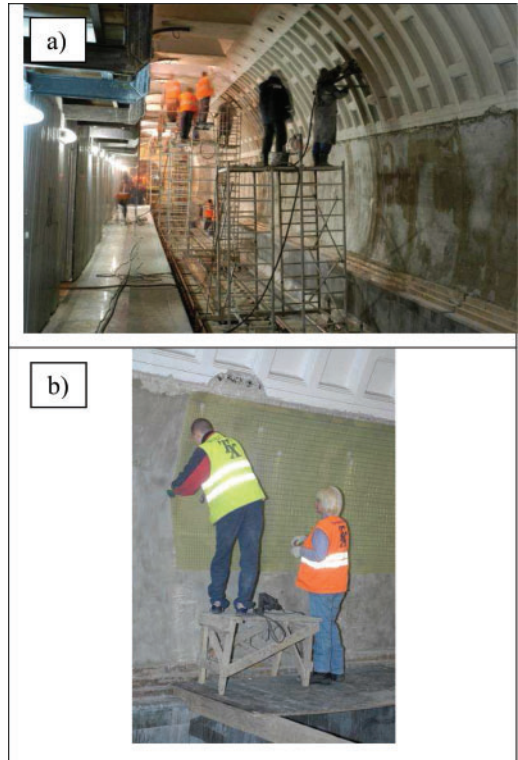
Figure 11. Waterproofing works in the side tunnel (a), installation of drainage sheets on the side tunnel wall (b).

In the side tunnels water leaked primarily through the joints between the lining segments and also through the plugs in the cementing ports and bolt connections.

As mentioned above, cast iron lining was covered by inner reinforced concrete lining (playing decorative part as well), and to preserve the original appearance of the station it was decided to make injections through the boreholes drilled around the plugged cementing ports from a specially assembled scaffolding (Fig. 7). Two rows of segments located above decorative marble panels were treated with injections. To be able to inject, plugs were removed from the ports.

To additionally protect decorative marble panels from moisture, dimpled drainage sheets were installed on the walls, thus creating a vented gap (Shilin et al. 2003). For this purpose marble panels were dismantled and the underlying wall surface was leveled. Then the dimpled sheets were installed, their bottom edges performed as a drainage chute. Afterwards plaster was applied on top of these and marble panels were put in place. In the end final installations of the drainage system were done to remove residual water.
