Complex reconstruction project of Mayakovskaya metro station in the centre of Moscow

A.A. Shilin, A.M. Kirilenko & P.A. Znajchenko
ZAO “Triada-Holding”, Moscow, Russia

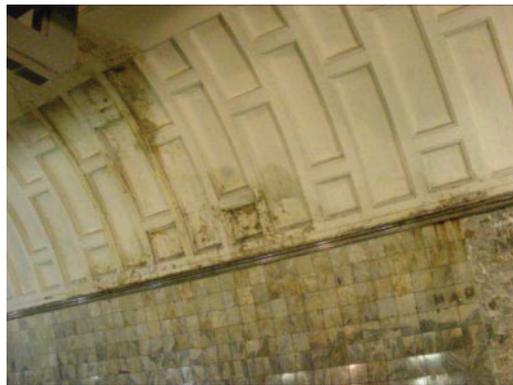
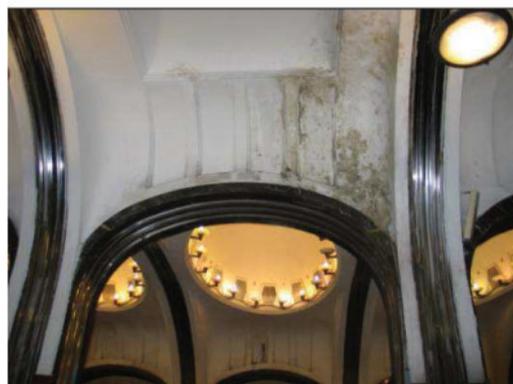
Intensive corrosion of metal structures and concrete reinforcement caused deterioration of finishing

Figure 3. Regular multiple leakages caused deterioration of station finishing.

materials. There appeared water leaks and drips in passenger passage areas.

structural wetting and spoilt finishing and decorative elements (Fig. 3);

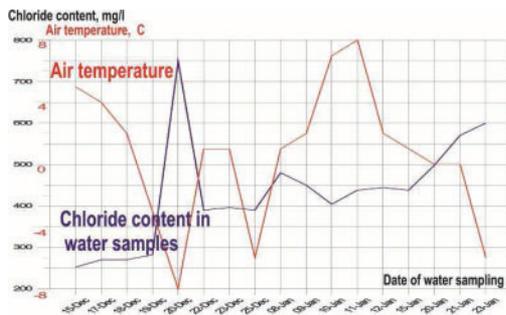
In 1986, 1997, and 2008 samples of leaking water were taken for analysis at the station, in the traction equipment chamber and in the escalator tunnel. Test results showed that the composition of water was altered greatly by various man-made activities in surrounding media. High chloride content made water aggressive towards concrete and steel reinforcement, whereas considerable quantities of calcium coming with water filtering through cement-sand grout from behind the lining caused drainage pipes blocking. The graph in Figure 4 demonstrates how chloride content in

Figure 4. Relationship between chloride content in water samples and temperature fluctuations above ground.

water grew as temperatures went down in winter, and chloride-based de-icing salts were used in the streets.

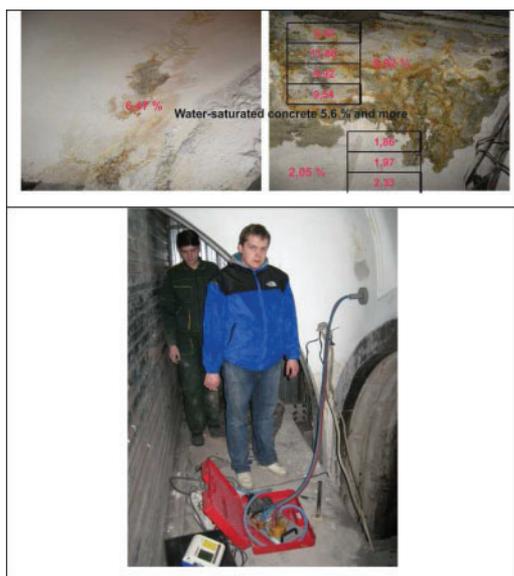
Figure 5. High permeability of concrete caused leakages and structural deterioration.

Concrete tests confirmed high degree of water penetration: W2, whereas current norms state W4 as the standard value (Kirilenko 2013). Concrete around the leaks was wetted to different extent (Fig. 5).

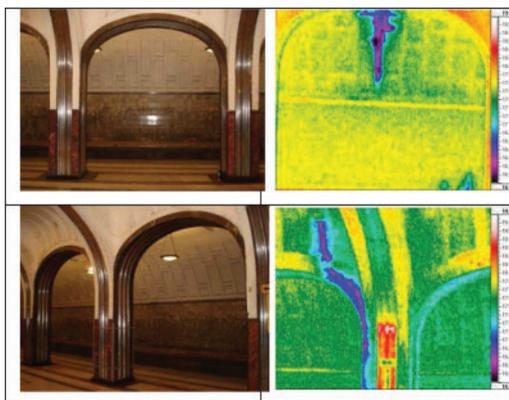
Infrared thermography was used to locate wetted areas which could not be defined visually, though clearly seen as “thermal spots” on structural surface (Fig. 6). Besides, it helped to create general map of heat distribution within the structures (Shilin et al. 2015).

Figure 6. Station structures in visible and infrared ranges.

- quite a number of areas were located where surface wetting could not be identified visually, though present inside the structures; those areas demanded urgent restoration of waterproofing;
- it was stated that water came mainly via the escalator tunnel which crossed water-bearing layers of soil.

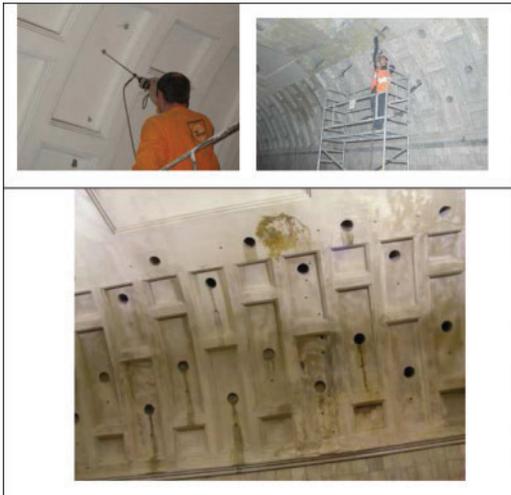
Figure 7. Locating and correcting positions of cementing ports.

structures, which we did with the help of endoscopes in the following way. First we drilled small holes (dia. 18 mm) in the places shown at the design drawings and inserted rigid endoscopes into them (Fig. 7). The images we got from inside the structures allowed to make corrections – if necessary – to drill afterwards holes of bigger diameter (80–100 mm).

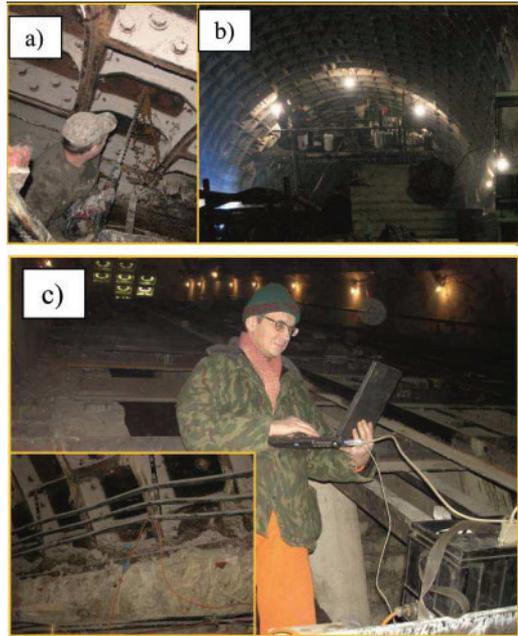
Figure 8. Drilling of a borehole through a cementing port in the segment (a), injections from the trolley-based rig (b), impact echo tests for quality control of injections behind the lining (c).

In the traction equipment chamber injections were carried out from the existing running bridges, in the escalator tunnel a special trolley-mounted rig was assembled for the purpose. Plugs from cementing ports were pulled out; through the ports boreholes were drilled to the depth of 500 mm crossing the layer of concrete plugging injected at the time of construction (Fig. 8a).

Quality of injections was controlled visually, by impact-echo tests (Fig. 8c), and also with the help of rigid/flexible endoscopes inserted into specially drilled boreholes. Besides, selective water tests were carried out, as well as continuous infrared thermography in the end.

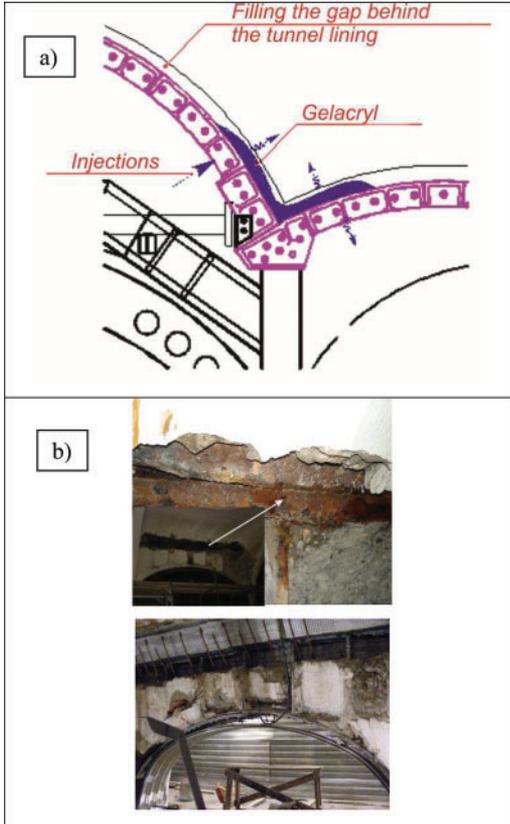
Figure 10. Scheme of polyacrylate gel injections (a), refurbishment of the failed drainage system (b).

At this stage a two-component polyacrylate gel was injected. This gel was capable to penetrate not only into the contact zone between the lining and surrounding soils, but also into fine cracks and pores in structures and soil (Fig. 10a). The job was carried out on a round-o'clock basis from the station vent channel.

additionally PVC flashings were installed instead of old ones made of ruberoid (Fig. 10b).

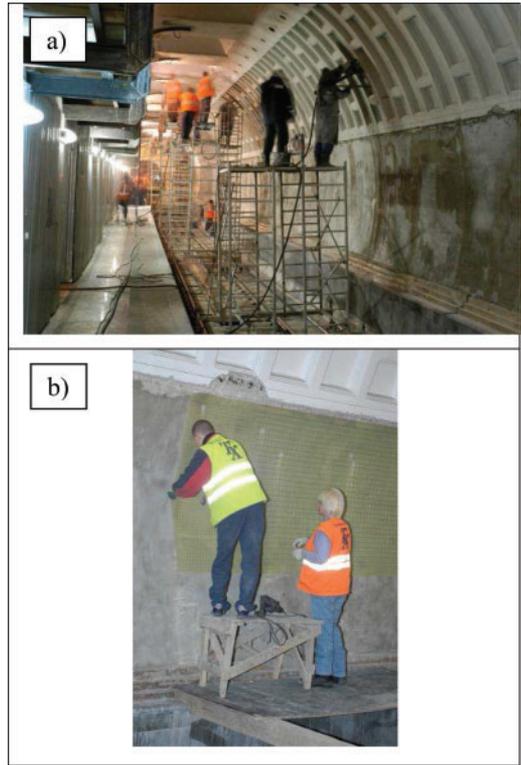
Figure 11. Waterproofing works in the side tunnel (a), installation of drainage sheets on the side tunnel wall (b).

In the side tunnels water leaked primarily through the joints between the lining segments and also through the plugs in the cementing ports and bolt connections.

To additionally protect decorative marble panels from moisture, dimpled drainage sheets were installed on the walls, thus creating a vented gap (Shilin et al. 2003). For this purpose marble panels were dismantled and the underlying wall surface was leveled. Then the dimpled sheets were installed, their bottom edges performed as a drainage chute. Afterwards plaster was applied on top of these and marble panels were put in place. In the end final installations of the drainage system were done to remove residual water.
