2 PROBLEM BACKGROUND

3 INSPECTION OF STRUCTURAL STATE AND STATION WATERPROOFING

4 EXECUTION OF RECONSTRUCTION AND WATERPROOFING WORKS

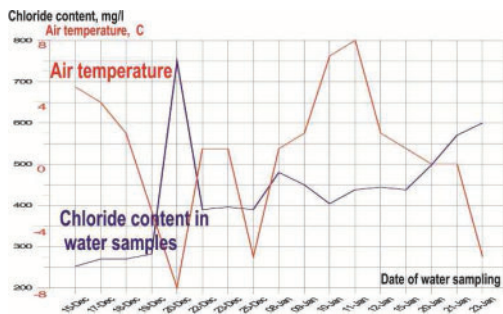
In 1986, 1997, and 2008 samples of leaking water were taken for analysis at the station, in the traction equipment chamber and in the escalator tunnel. Test results showed that the composition of water was altered greatly by various man-made activities in surrounding media. High chloride content made water aggressive towards concrete and steel reinforcement, whereas considerable quantities of calcium coming with water filtering through cement-sand grout from behind the lining caused drainage pipes blocking. The graph in Figure 4 demonstrates how chloride content in

Figure 4. Relationship between chloride content in water samples and temperature fluctuations above ground.
