Complex reconstruction project of Mayakovskaya metro station in the centre of Moscow

A.A. Shilin, A.M. Kirilenko & P.A. Znajchenko
ZAO “Triada-Holding”, Moscow, Russia

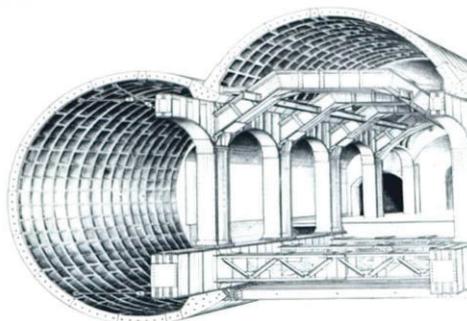
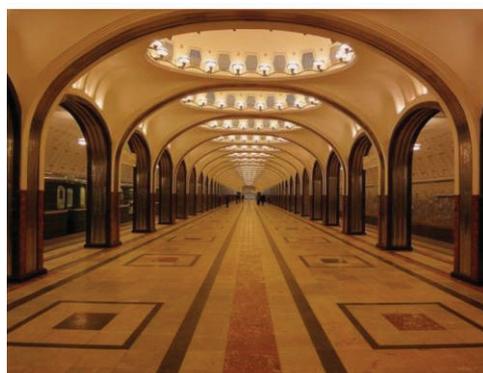
At the time of its construction, Mayakovskaya was the first station of a new design type, a deep triple-span column station, where the central vault was supported by colonnades on each side instead of traditional pylons. The lining of the station was made of prefabricated cast iron segments. Each of the two side tunnels has the diameter of 9.5 m. The vault of the central station tunnel is located 2.5 m higher than the vaults of the side tunnels and is supported by their lining which is additionally secured by steel beams and columns along the line of support. Columns are also supported by steel beams from beneath. Steel cross beams connect the columns in the upper part of the station span, thus adding rigidity to the whole structure and making it stable (Fig. 1).

Steel lattice struts help to keep lower steel beams in place, preventing them from moving. Space between upper cross beams and the vault serves as ventilation channel.

Figure 1. Load-bearing structures and central hall of the station.

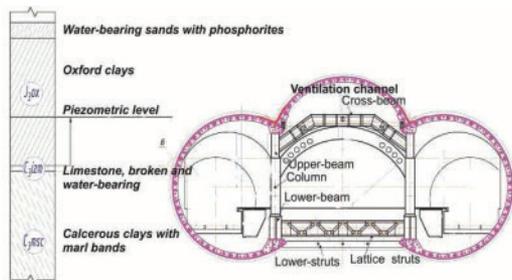
Figure 2. Geology in the area of Mayakovskaya station. Station Cross-section.

Another factor which defines the quality of waterproofing is the geological environment of an underground structure. Moscow is located in the centre of the so-called Russian platform which has a vast crystalline foundation covered by a layer of basic sediments, upper part of which is represented by man-made soils, loams, clay sands, and unstable water-saturated sands. Deeper these are followed by clays with bands of limestone. Station structures lay mainly in this layer. It shall be noted that the vault of the station is located in Oxford clays with bands of water-bearing sands and phosphorites, the presence of which had not been known and hence accounted for at the design stage (Fig. 2).
